Root cause audio issues during a voice readiness assessment.

During a paid-for readiness assessment of a customer WLAN for voice support there were large audio gaps, longer than should be experienced even with slow roams. Protocol Analysis was used to determine the cause.

This was a brand-new healthcare building being assessed ready for opening. There were almost no other clients associated to the WLAN at the time of testing.

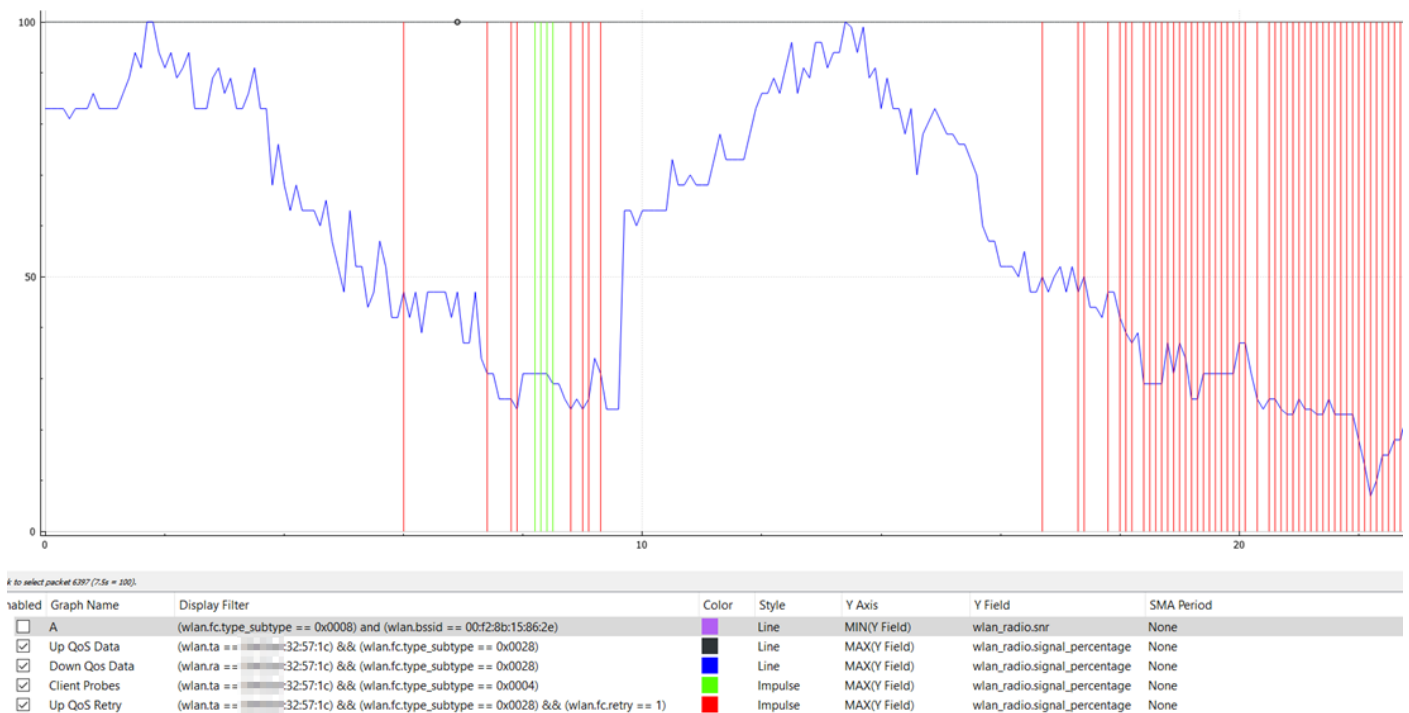
Figure 1 - Data Stream Graph

Figure 1 shows us that the voice conversation was working well for the first ~17 seconds. Very few retries (red bars), downstream signal (blue line) decreasing and increasing as I move from AP to AP, and probes (green bars) when signal gets low enough to warrant a roam.

However, at ~18 seconds the upstream retries (red bars) start increasing until they are constant. The downstream signal strength (blue line) keeps dropping lower and lower, and the client keeps transmitting constantly (black line along top). But you do not see any probe requests (green bars) from the client to initiate a roam.

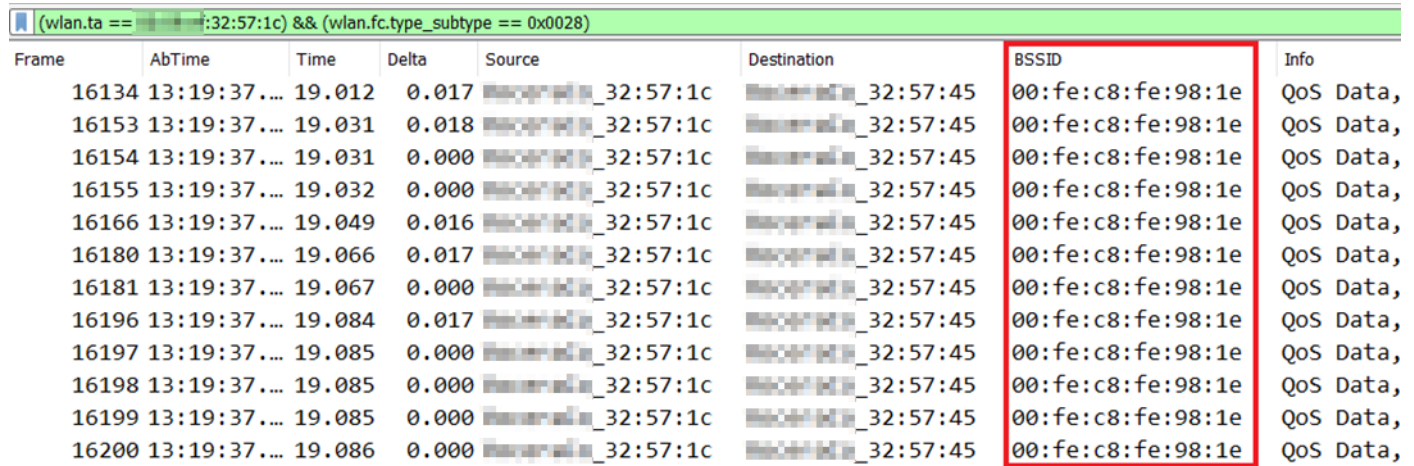
Figure 2 - Associated BSSID

The client uses Beacon strength to determine its connection quality, so now I needed to verify beacon strength of the BSSID. Figure 2 shows that at 19 seconds the client (00:09:ef:32:57:1c) was transmitting its data frames to (therefore associated to) BSSID 00:fe:c8:fe:98:1e.
